Manhole Inspection Summary

Manhole # S41E2_013MH

Insp Date: **12/13/07 7:35 AM**

Location Address: **4200 6th St** Cross Street: **Townsend Ave**

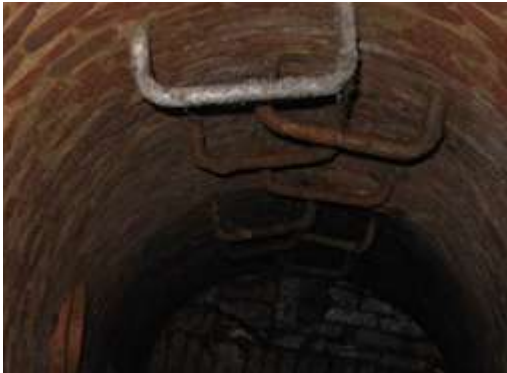
Defect 1

Chimney / Frame Adjustment ☒ Exists Material: **Brick and Concrete** ☐ Parged Height: **2** (in.)
Condition: ☐ Sound ☐ Cracked ☐ Root Intrusion ☒ **Loose Brick** ☐ Deteriorated
Infiltration: ☒ None ☐ Joint ☐ Cracks ☐ Mortar ☐ Roots ☐ Wall
